New York State Department of Transportation

Yellow Flag NB23U4W022

BIN: 1065318

Feature Carried: 278I278IX2M23027

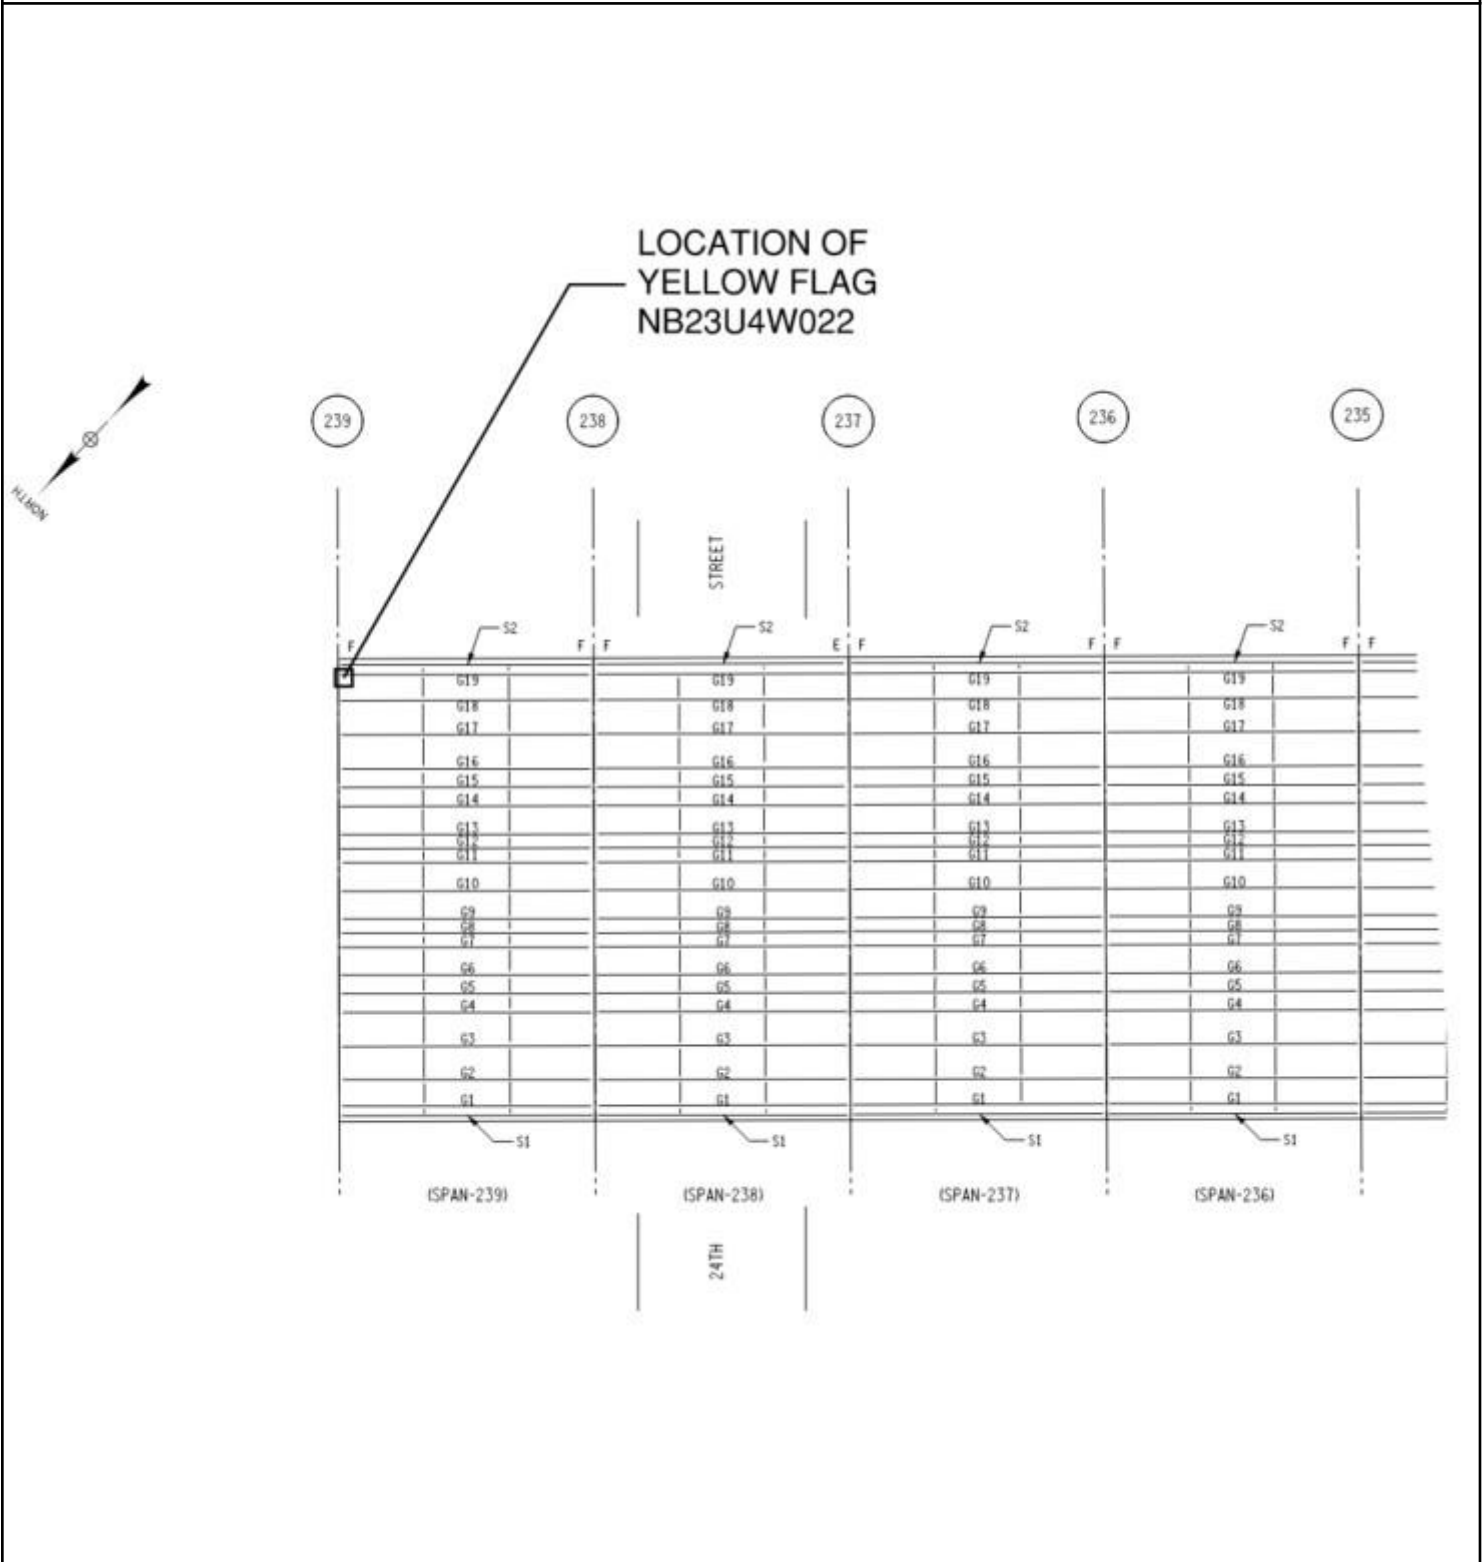
Photo Number: 1

Attachment Description: FLAG LOCATION PLAN

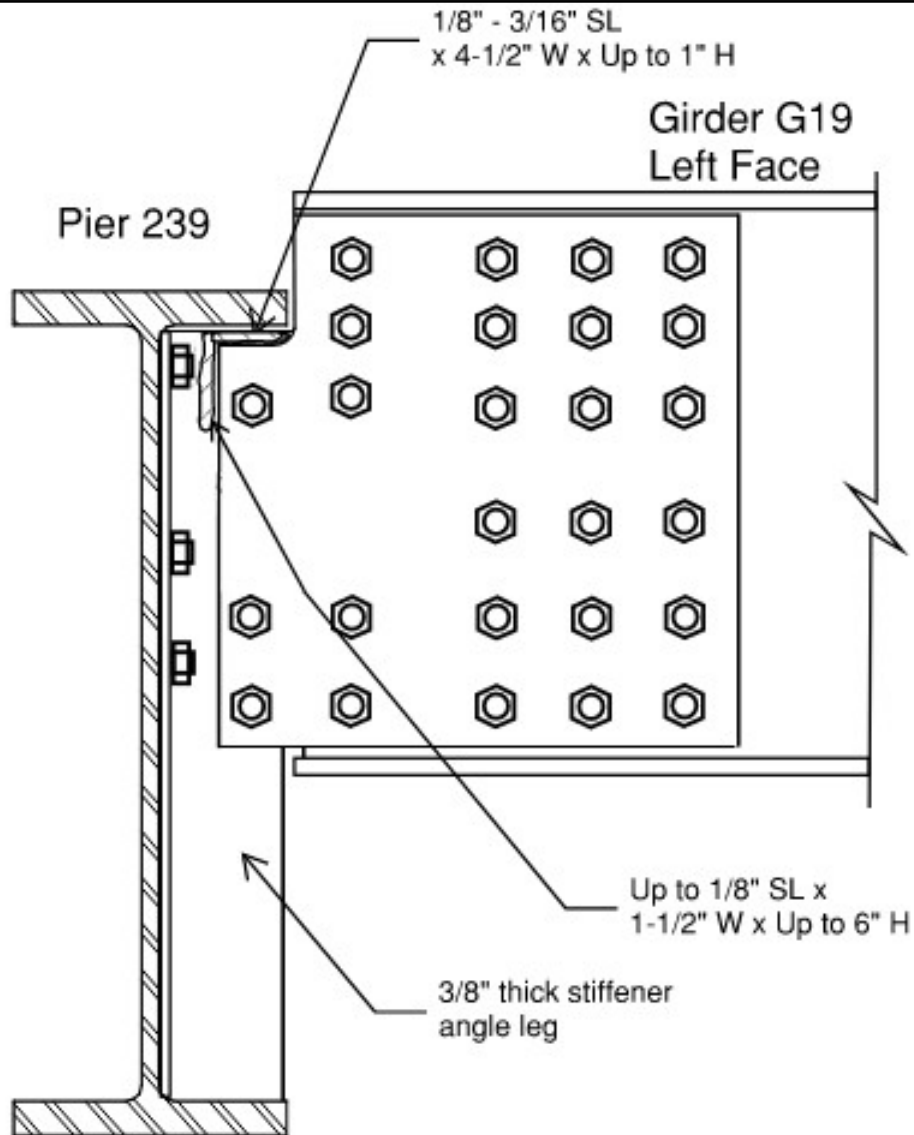
Photo Number: 2

The right connection angle of Girder G19 at the connection to Pier 239 exhibits a full height vertical corrosion crack for 1/16" - 1/8" wide in the connecting leg.

SKETCH FOR YELLOW FLAG # NB23U4W022
SPAN 239, GIRDER G19 AT PIER 239
(LOOKING RIGHT)
N.T.S

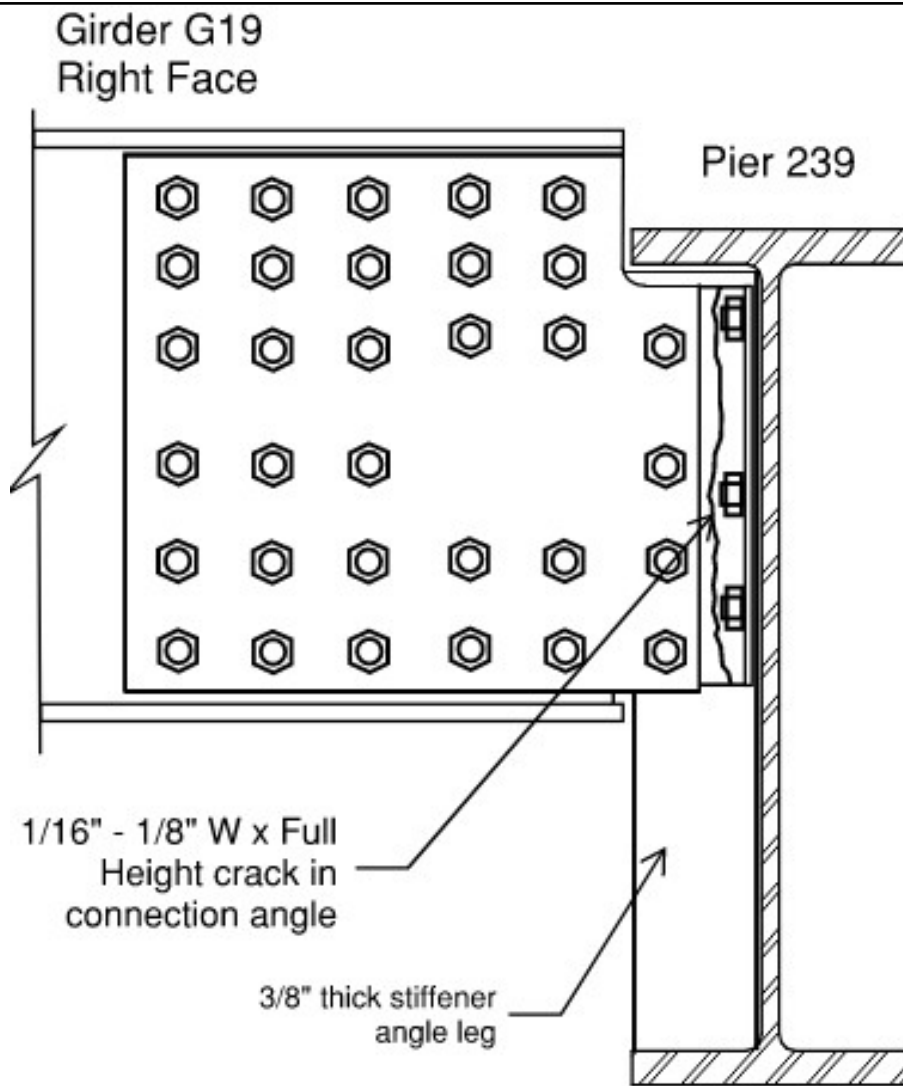
Photo Number: 3

In addition, the left stiffener connection angle of Girder G19 to Pier 239 exhibits:

1. Up to 1/8" section loss (1-1/2"W x up to 6"H) in the connecting leg portion, adjacent to the vertical edge of the girder web end,
2. 1/8" - 3/16" section loss (4-1/2"W x up to 1"H) in the top portion of the connecting leg portion, above the girder web.

SKETCH FOR YELLOW FLAG # NB23U4W022
SPAN 239, GIRDER G19 AT PIER 239
(LOOKING LEFT)
N.T.S

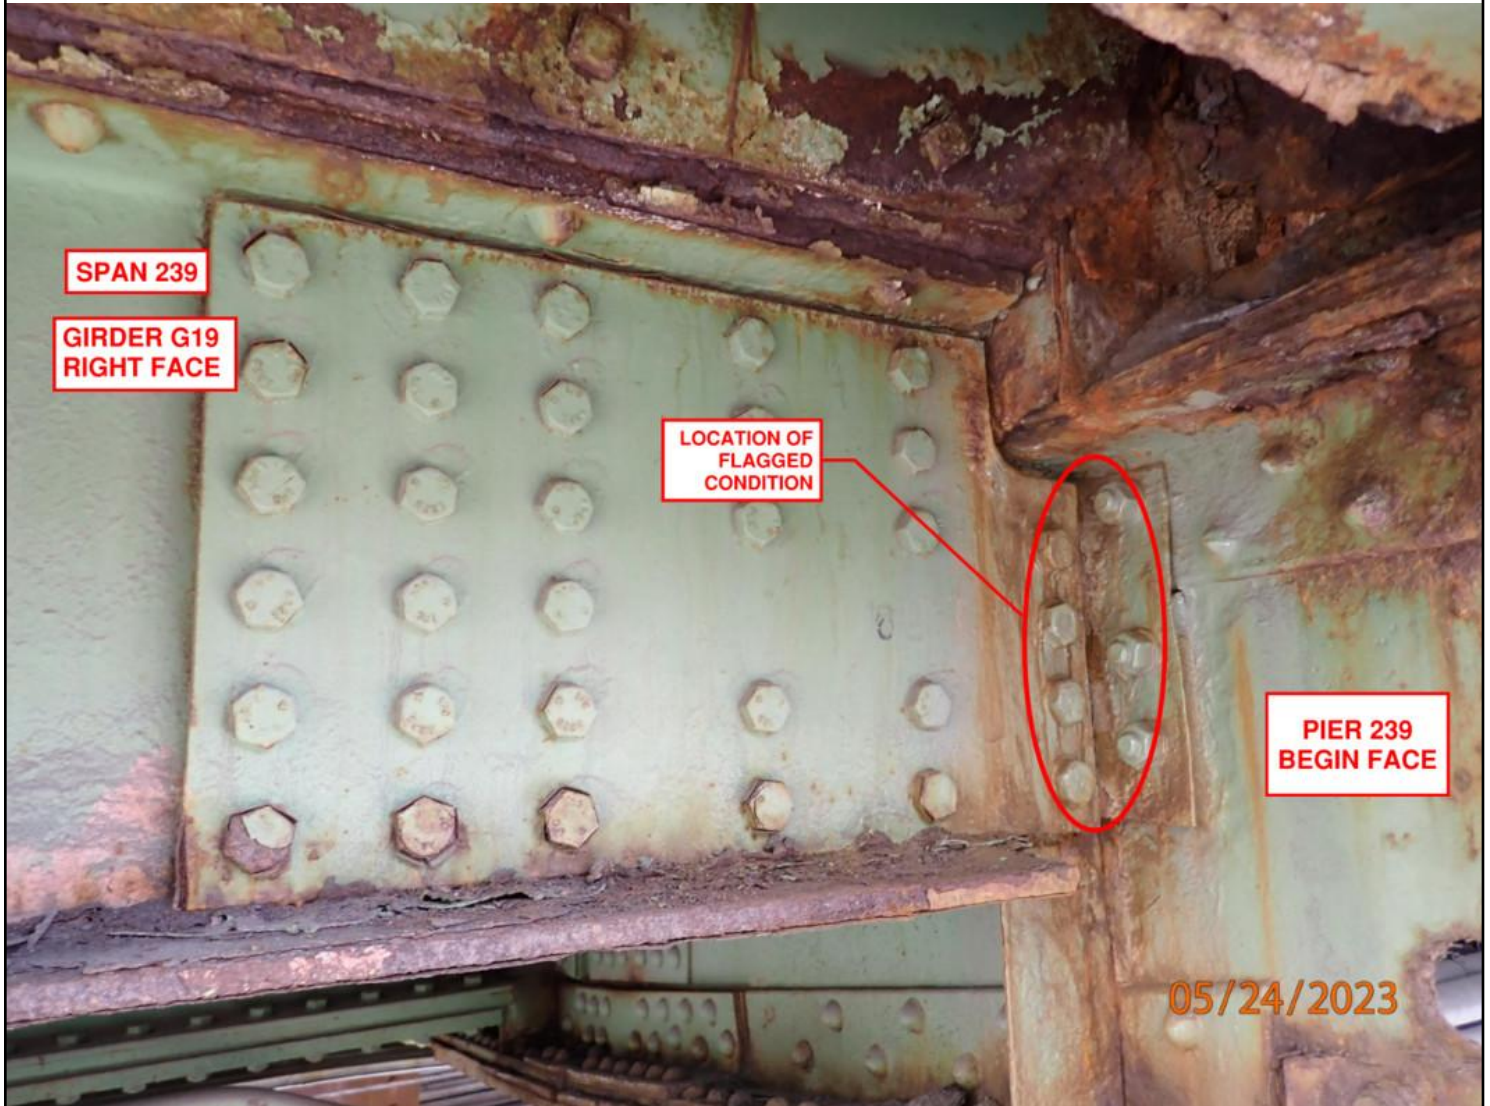
Photo Number: 4

Attachment Description: General View of Flag Location on Right Face of Girder G19. Looking End - Left

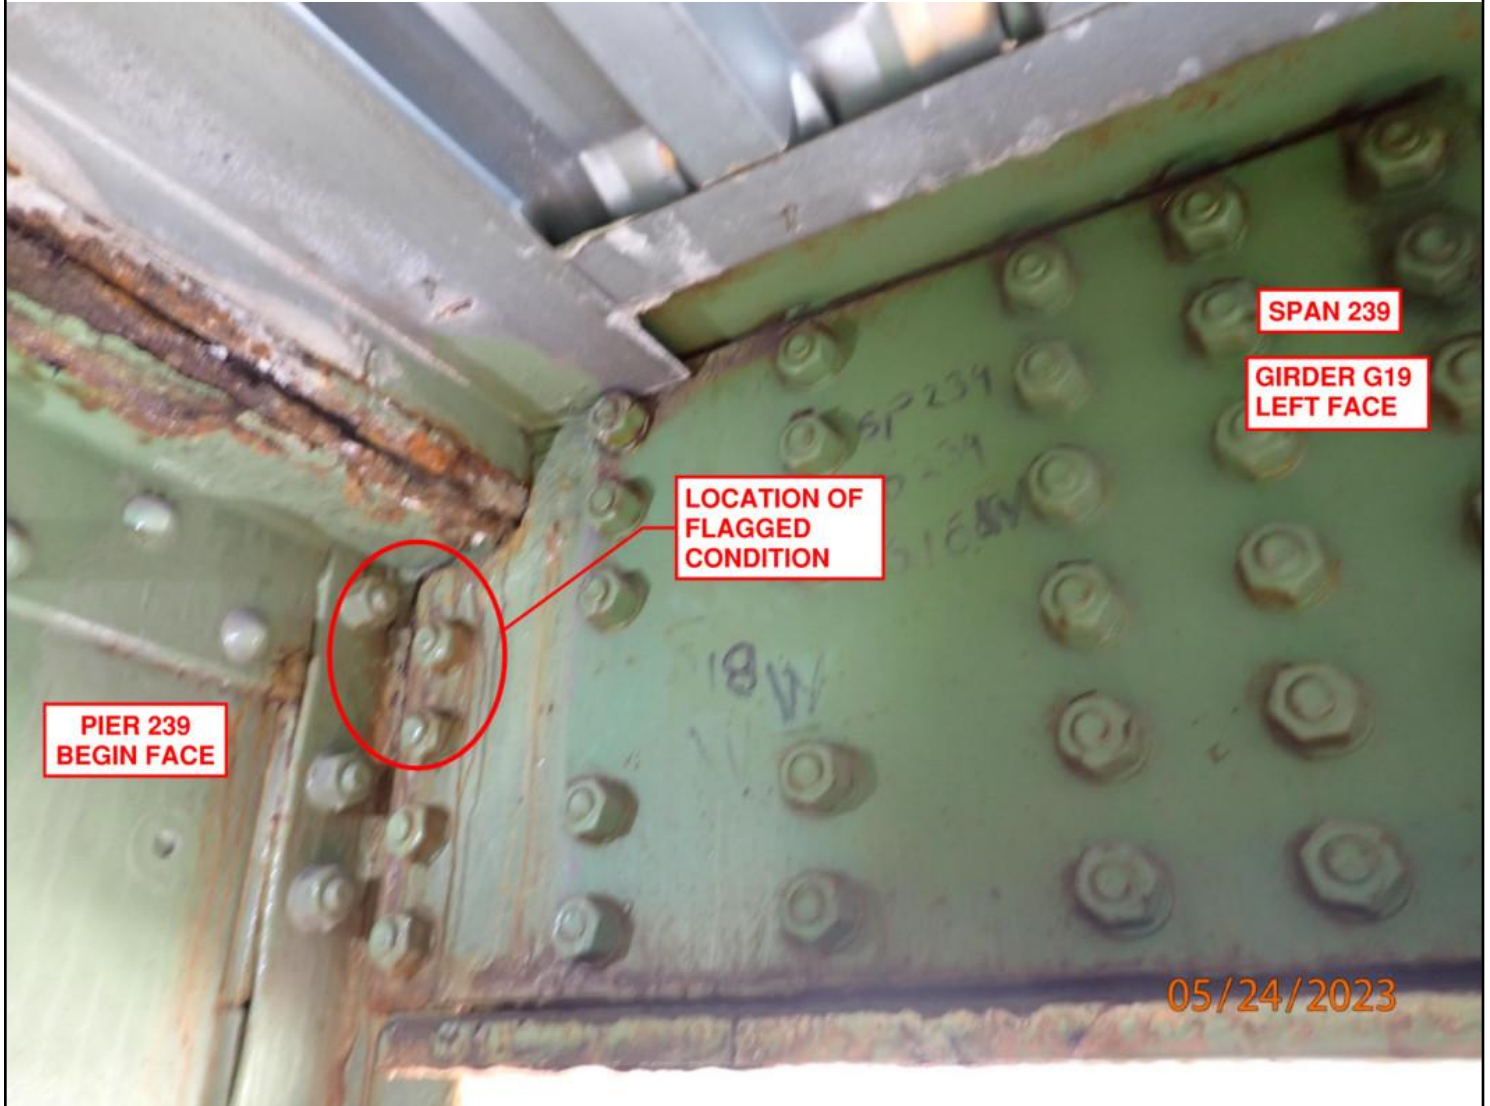
Photo Number: 5

Attachment Description: General View of Flag Location on Left Face of Girder G19. Looking End - Right

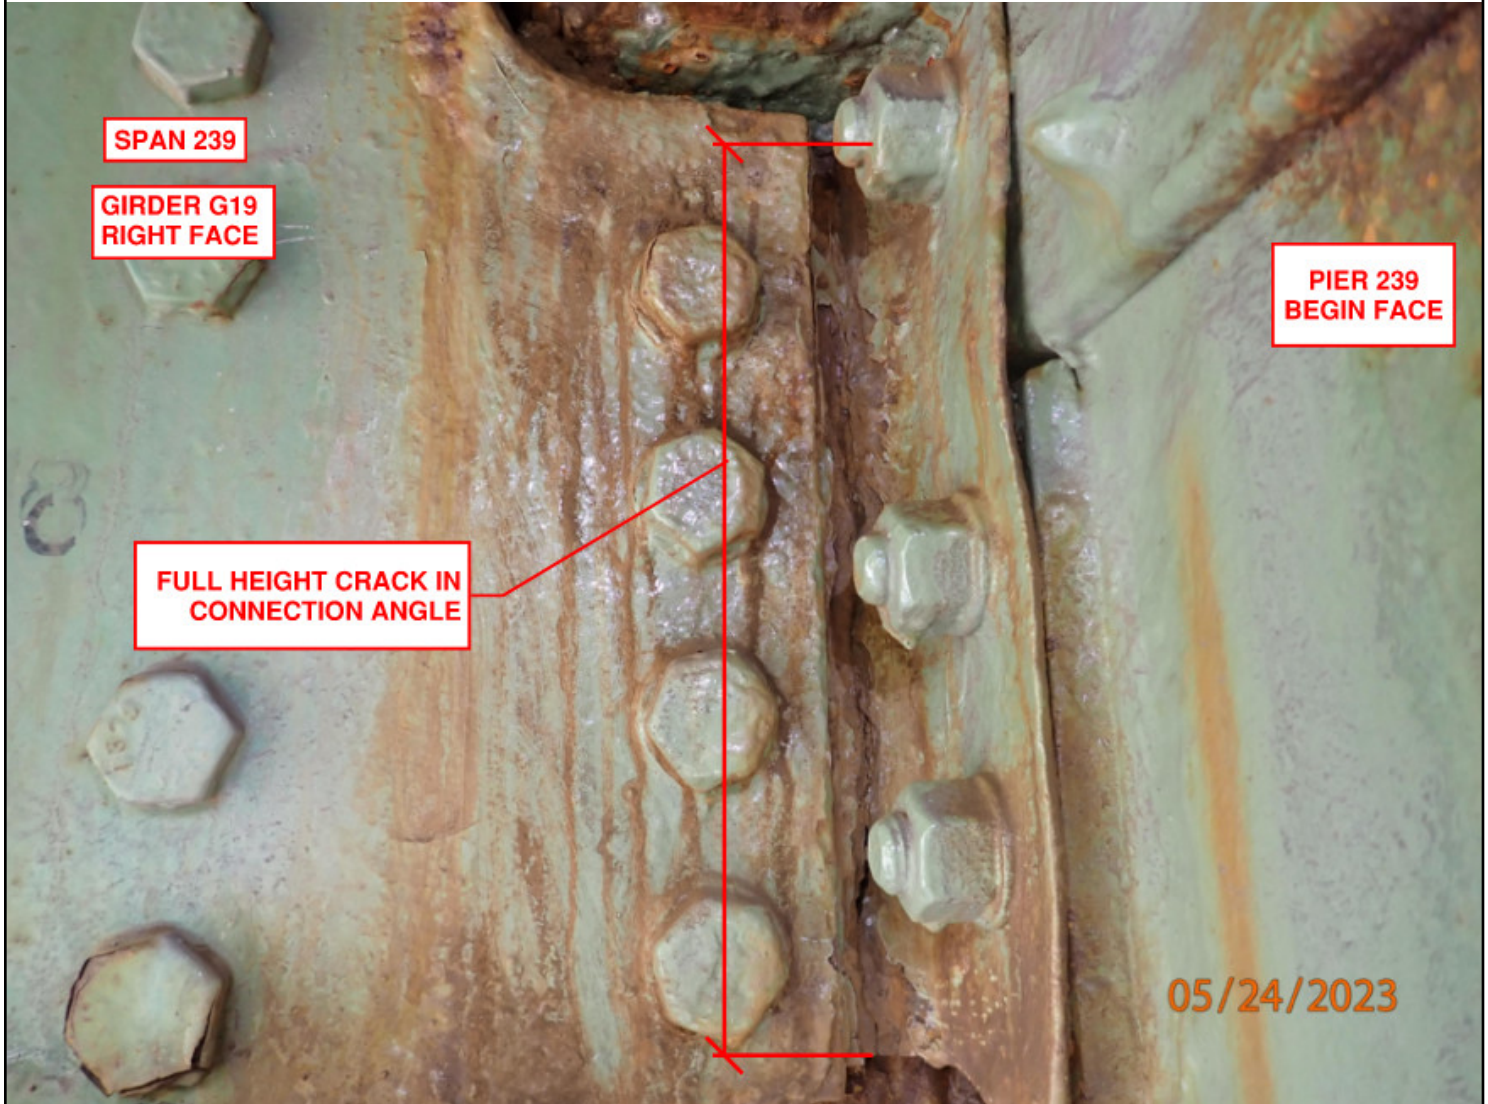
Photo Number: 6

Attachment Description: The right connection angle of Girder G19 at the connection to Pier 239 exhibits a full height vertical corrosion crack for 1/16" - 1/8" wide in the connecting leg. Looking Left.

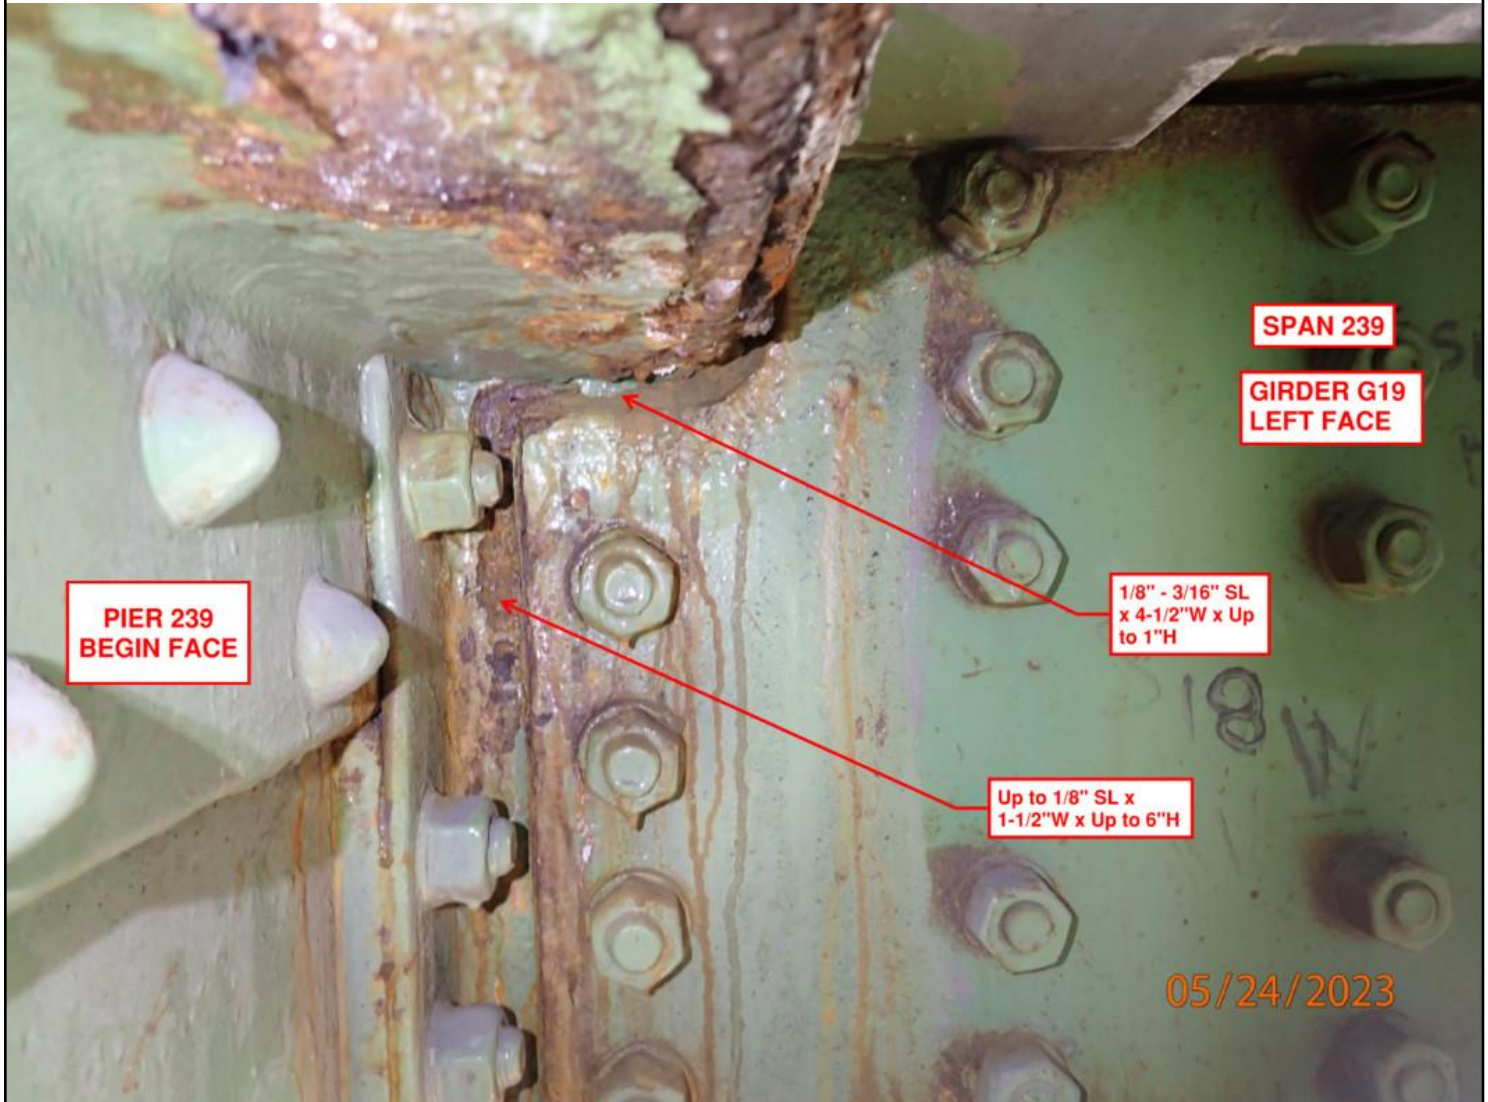
Photo Number: 7

Attachment Description: Stiffener angle has up to 1/8" section loss (1-1/2"W x up to 6"H) in the connecting leg portion, adjacent to the vertical edge of the girder web end,. There is 1/8" - 3/16" section loss (4-1/2"W x up to 1"H) in the top portion of the connecting leg portion, above the girder web. Looking Right.
